# ANATOMY OF A NOSE<sup>210</sup> WHEEL COLLAPSE ON LANDING

by Eric Woodman

## Nose Gear Spring Guide & Actuator Pin Inspection

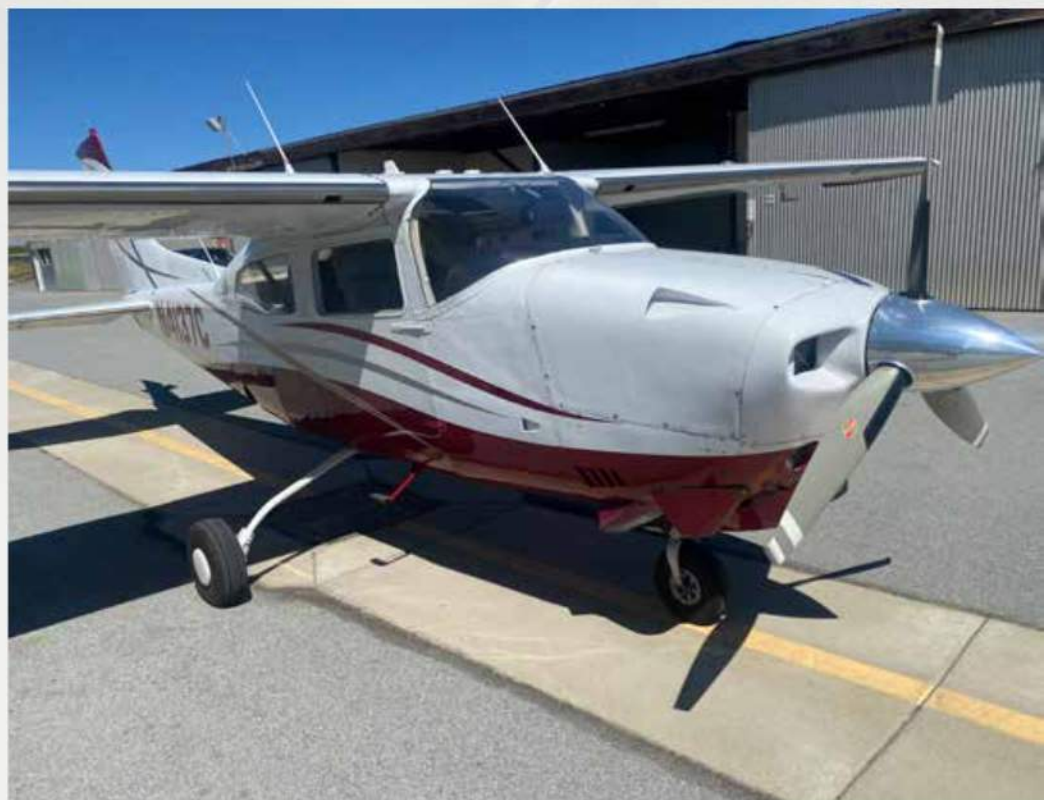
Approaching to land at Truckee, CA, in my 1979 T210N, the green gear down-lock indicator light did not illuminate. More attempts to cycle the gear up and then down did not solve the problem. I believe the gear pump turned off at the end of each down and up cycle. Using the manual gear pump, I found maximum pressure in the lines made it impossible to pump the extended handle. The pilot's-side main gear appeared to be in position to be locked. Looking at the passenger-side mirror showed the right main gear also in position to be locked. The mirror view seemed the same for the nose wheel.

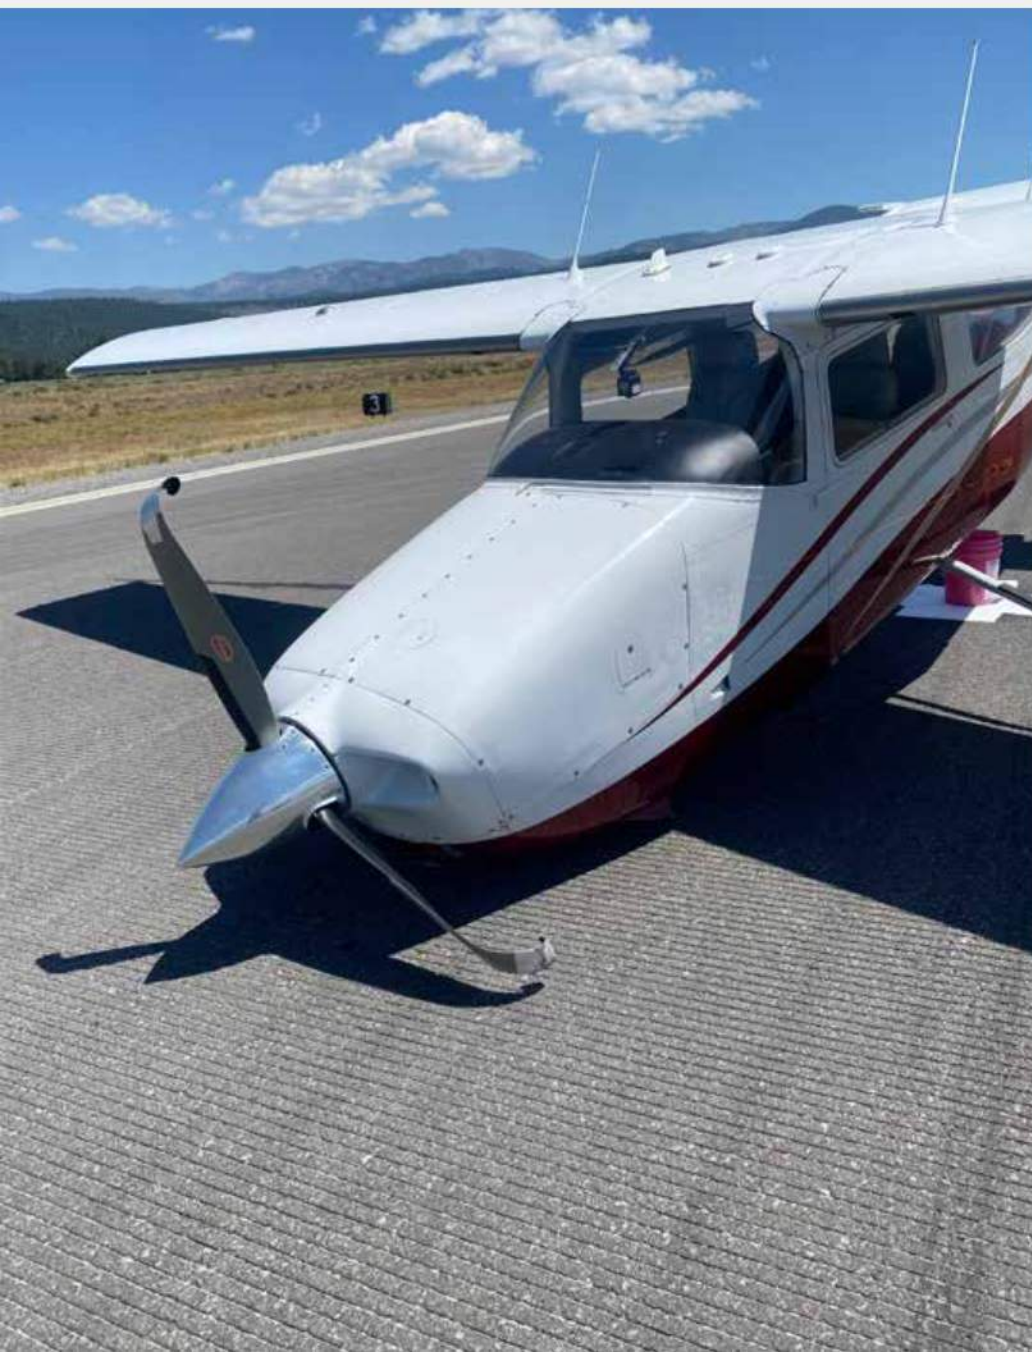
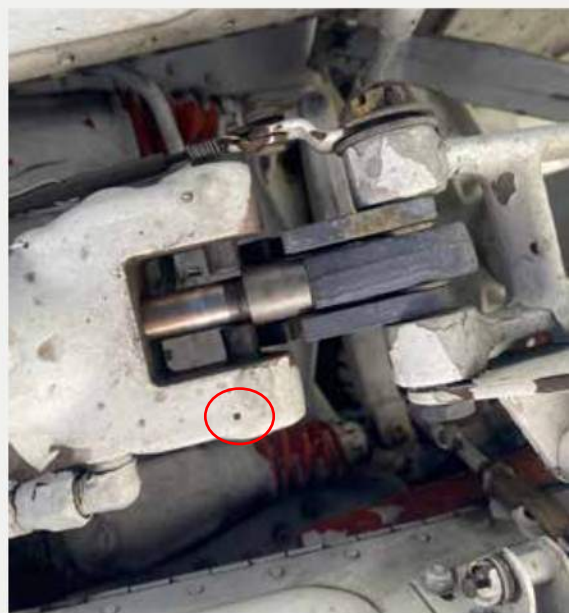
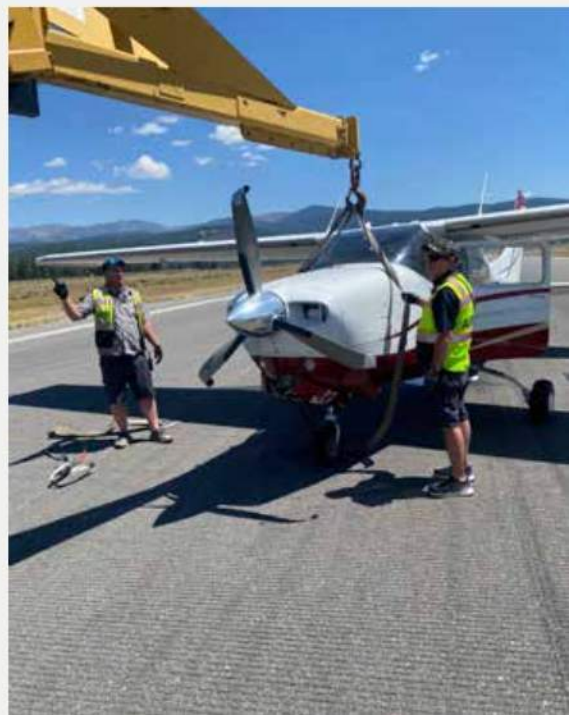
The nose was lifted with the use of a crane and webbing. Attempts to swing the nose gear into locked position failed. Crawling under the plane behind the nose wheel, I discovered a down-lock pin had migrated out of its hole far enough to block the collar at the end of the actuator rod so the rod couldn't pull the nose wheel back far enough for the down-lock hooks to engage the pins.

See the lower pin in the attached photo. The upper pin has a 1/4" gap for passage. The lower pin was not loose and could only be moved back by hammering a wedge between it and the rod. Once the pin was forced away from the actuator rod, the nose wheel could be moved by hand into the locked position and the plane was towed off the runway.

CPA tech support specialist Garth Bartlett responded to my support ticket: "The problem you have with the down-lock pins migrating out of place is very common on aircraft that don't have regular inspections of the pins for looseness as recommended by Cessna SEB 95-20. This SEB was introduced in 1995 and recommends the pins be inspected for looseness every 200 hours or 12 months (whichever occurs first) and repeated at each gear retraction inspection (while on jacks) not to exceed 200 hours of operation after the initial inspection.

While Cessna never said so, the general consensus about the cause of the pins' becoming loose is the use of powered towing devices such as tractors, tugs, etc. These machines put a jerking motion on the pins, which leads to looseness.

The pins are retained in the nose actuator housing by two roll pins, one for each downlock pin. These retaining pins are very small diameter, very weak and break easily, leading to the looseness of the pin, which allows it to start migrating.

SEB 95-20 introduces a service kit SK210-155. This allows the down-lock pins to be replaced with larger diameter down-lock pins and larger diameter roll pins.

I would suggest that in the future, your mechanic should carefully check the down-lock pins for looseness every annual, even if you modify the down-lock actuator with the service kit."

Yes!  
My two cents: Inspect for the gap between the pins and the nose gear actuator rod as part of every pre-flight. Request your mechanic to do the same during all his inspections, as well.

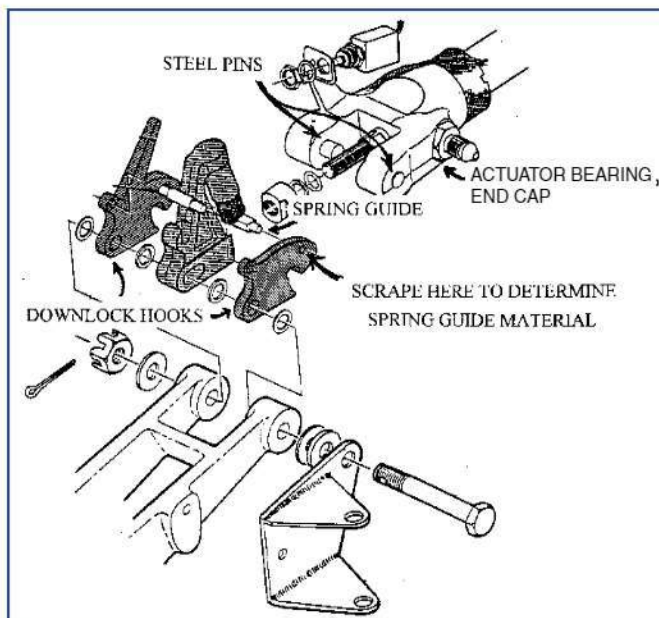
There have been problems with the nose gear actuator bearing end pins that the downlock hooks engage. Service Bulletin SEB95-20 for the single engine aircraft and MEB95-14 for the 303 and 337 series aircraft advises owners to have the pins inspected for looseness. The pins are a press fit in the actuator bearing end and retained with a roll pin. The bearing end pins break at the retaining groove that the roll pin engages. This allows the pin to back out and prevents the downlock hooks from

engaging properly.

These pins should be looked at whenever the aircraft is on jacks. This inspection can easily be done with a small pair of needle nose vise grip pliers. The pliers should have the serrated teeth ground off so the pliers do not gall the pins. With the pliers clamped to one of the pins, look for any movement in the pin while attempting to rotate the pin with the pliers. The pin is a press fit, so there should be no

movement in any direction. Check the other pin in the same manner. If any looseness is detected, the actuator bearing will have to be inspected to see if the hole size for the pin is still within limits. The maximum size for the downlock pin bore is 0.3760 inches. If the holes are out of tolerance, the bearing end will have to be replaced. If the bearing end is serviceable, the kit described in SEB95-20, SK210-155 for the single engine aircraft or MEB95-14 for the 303, SK303-47 and 337, SK337-70 aircraft can be installed. The new pins contained in the kit are retained by a roll pin that passes through the center of the pin so new holes must be drilled in the actuator bearing end. A drill guide is provided in the kit.
