## R/TR182 Main Landing Gear Actuator Bushing Inspection Guideline

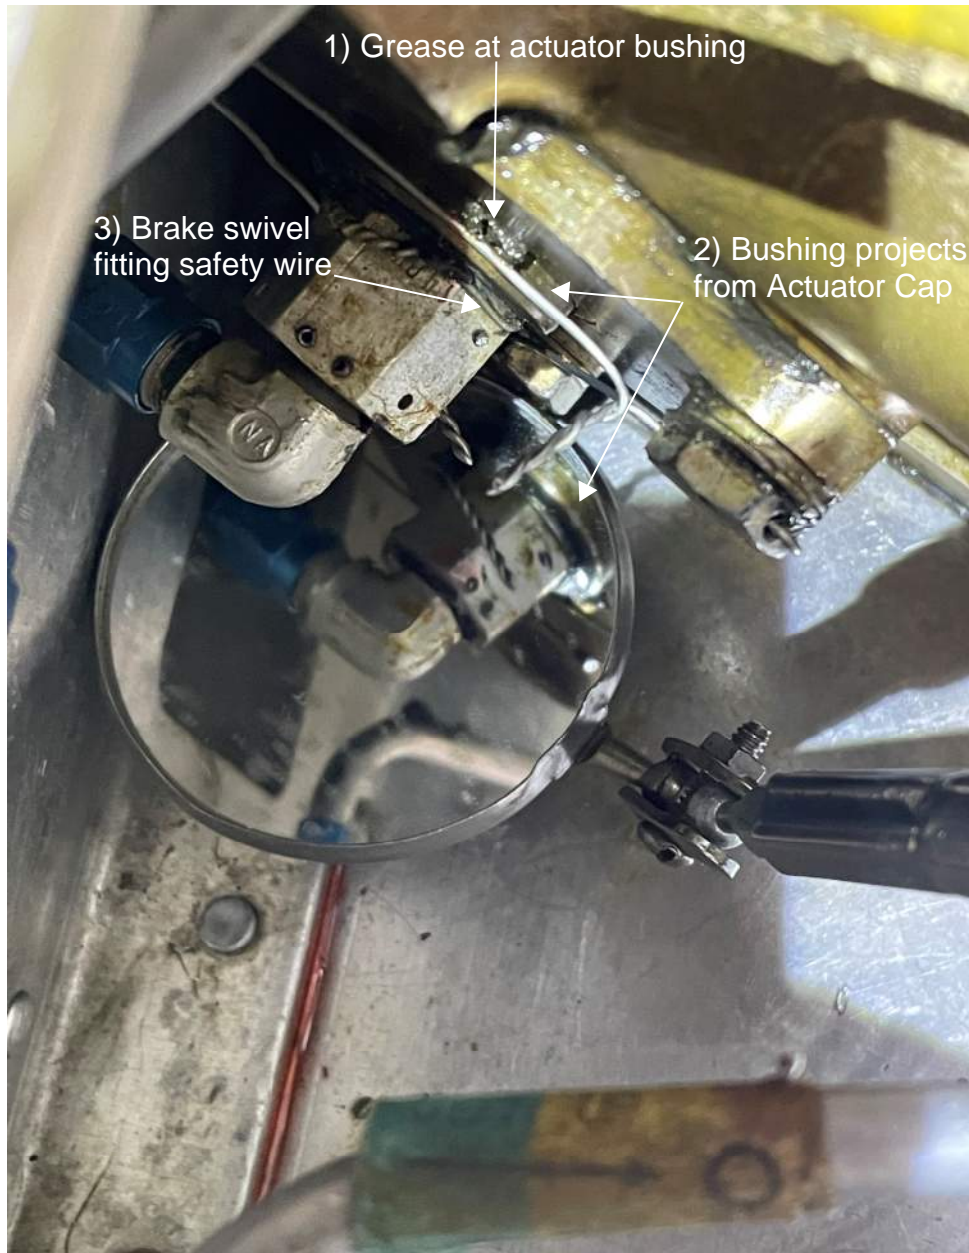
- 1) Grease emitting from below brake swivel fitting was 1st indication of failing MLG actuator bushing.
- 2) Bushing flange projects from actuator cap when it should be flush.
- 3) Brake swivel fitting safety wire is holding the actuator bushing in position, and resisting bushing movement from projecting further out of the actuator cap
