A&P/IA MEMBER TELLS THE TALE OF CHASING CESSNA CARBON MONOXIDE

By Jerry LeCroy

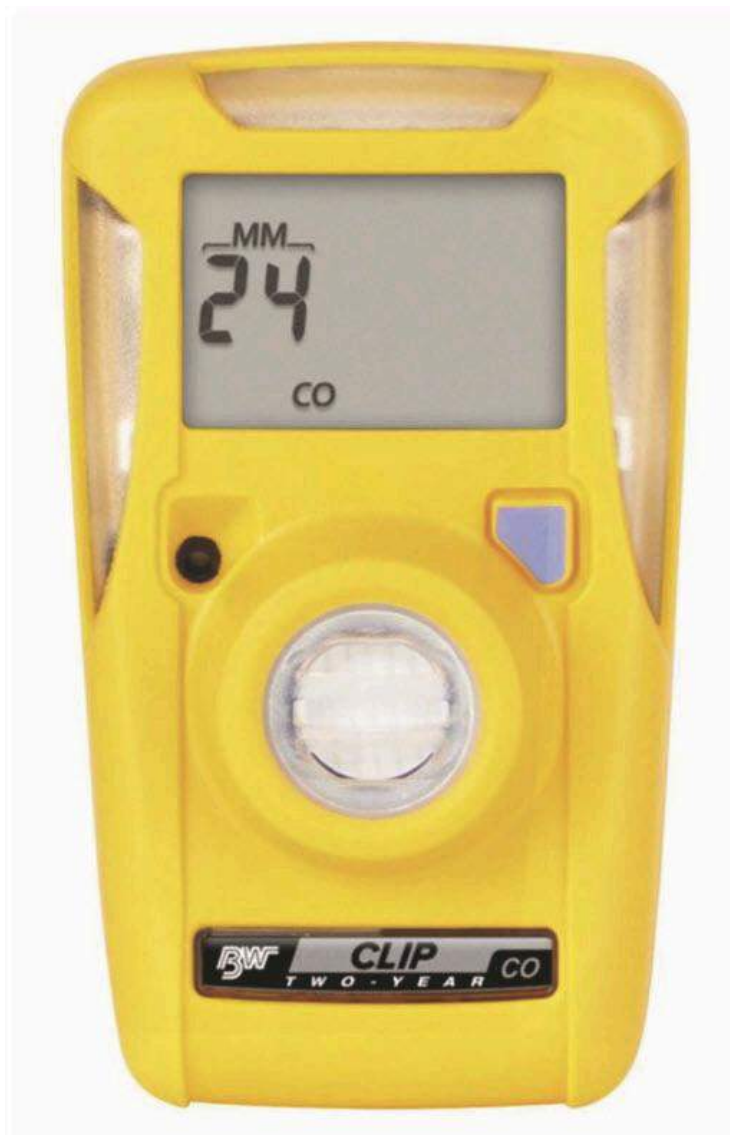
HONEYWELL BW CLIP

The BW Clip is used as a personal gas monitor by workers in several industries. They come in several flavors — multi-gas, hydrogen sulfide, low oxygen, and of course the ever-popular carbon monoxide. I used one of these instruments for the first time back in 2000, when I was doing some indoor noise testing on a propane-fired generator and didn't want to be a carbon monoxide test casualty.

The Clip has essentially no user adjustments but offers a digital display of CO level in ppm. The one I selected has preset alarms at 20 and 35 ppm. It is designed to last two years, and a countdown timer starts when the owner first powers it up. No replacing the battery or detector — just buy another Clip after two years. It comes out to less than five bucks a month; cheap if it only saves your life once.

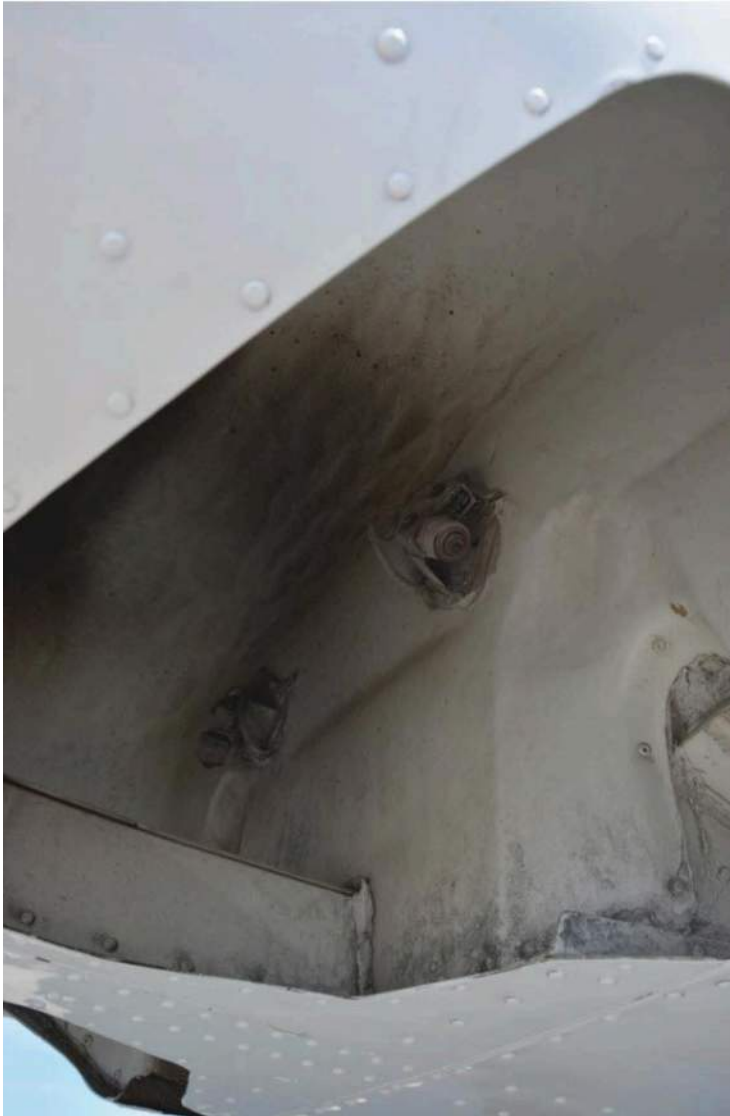
This wheel well photo was taken during our prepurchase inspection. Clearly the aircraft broker had someone work pretty hard to make it all clean.

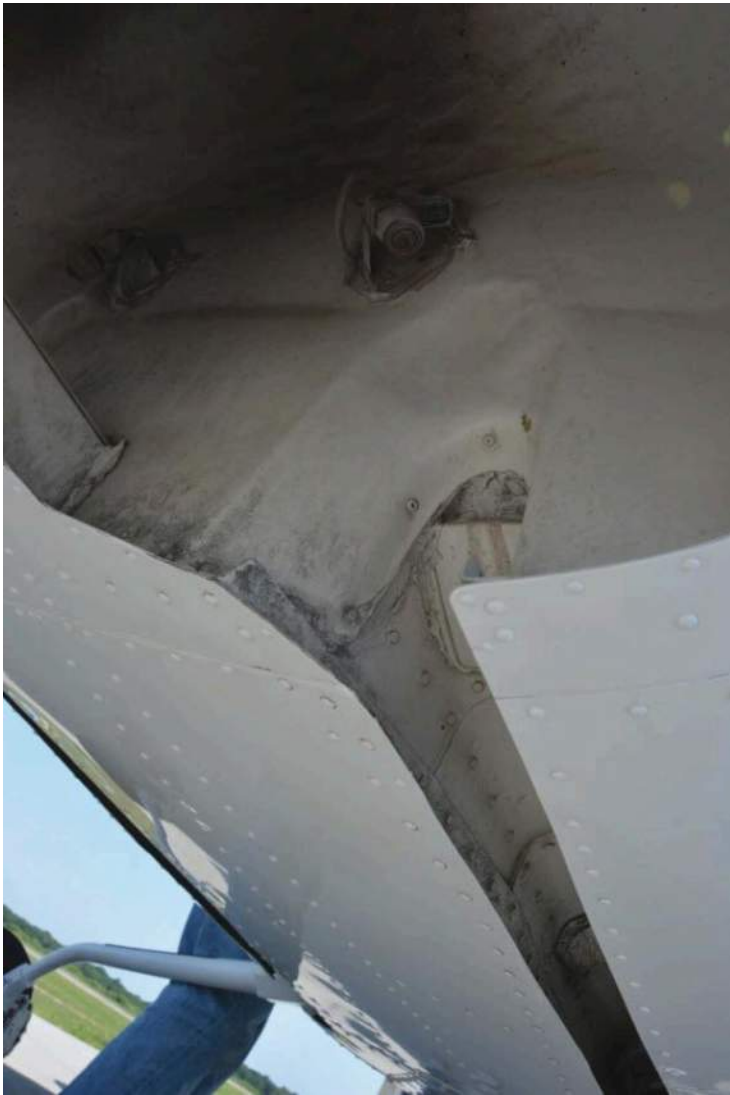
The gear tunnels also started out fairly clean.

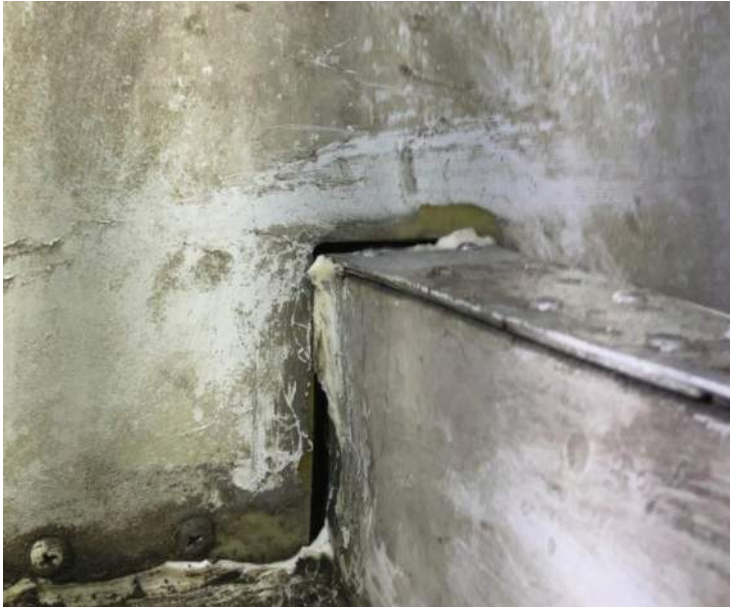
Forward end of the gear well center longeron where it penetrates the gear well liner. This was after degreasing but before scrubbing to remove the remaining loose RTV. The gaps are quite noticeable.

On our plane, at some time in the past, it appears that parts of the original seal failed. Some previous maintainer appears to have resealed the gaps with white silicone seal (bath/shower caulk?). After a few years, exposure to structural deflection under air loads and belly oil combined to cause that seal to fail. There were substantial gaps visible.

Aha! I guess that the doorless wheel well acts just like an air scoop and gets somewhat pressurized with an air-exhaust mixture in flight. If there are gaps between the fiberglass liners and airplane structure, the gas will then find its way into the cabin.

What to seal it with? My thinking was that the best sealant would be fuel tank sealant, as specified in the airplane maintenance manual. We did not have any of that material on hand, so I tried a stop-gap solution with Permatex Ultra Black gasket maker. This is just another form of silicone RTV, but it has some fillers that make it stronger, and it is rated to withstand a fair amount of fuel and oil exposure.

After spending a fair amount of time scraping off as much of the old white silicone seal as possible with a plastic scraper, Scotchbrite, and rags, I applied masking tape to limit the RTV spread.

With the area masked off, I went to town with a tube of Ultra Black. A day after the first application, I went back to reinforce any areas that appeared to be thin. I gave the goop another day to cure, then did a test flight.

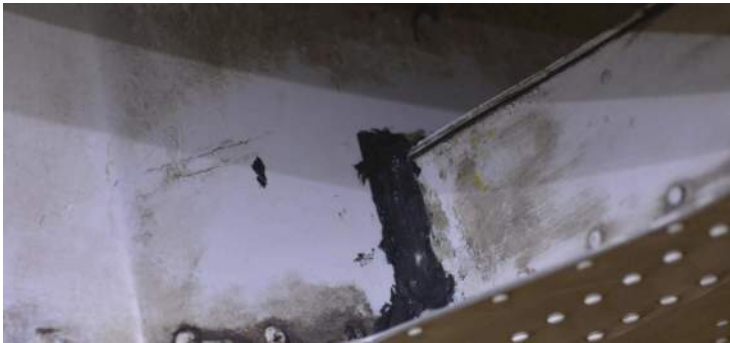
Forward end of wheel well after sealant application.

Success! We saw an initial 10 ppm on the monitor, which I attribute to another run-up with a tail wind. Once we were in the air the monitor mostly showed CO level at zero, with an occasional blip to 4 ppm (the lowest level the Clip will display). There were grass fires in the area, so the CO I saw in flight might have been supplied externally. Once I got away from the local area that had fires, the CO monitor settled down to a steady zero.

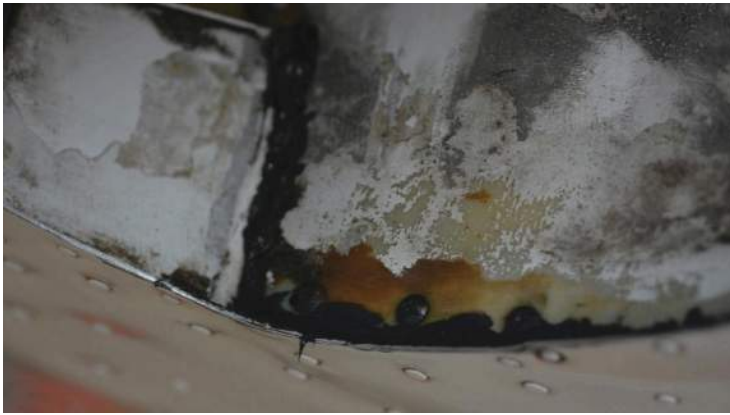
Aft bottom of wheel well after sealant application. What a mess!
