# ANATOMY OF A NOSE<sup>210</sup> WHEEL COLLAPSE ON LANDING

by Eric Woodman

## Nose Gear Spring Guide & Actuator Pin Inspection

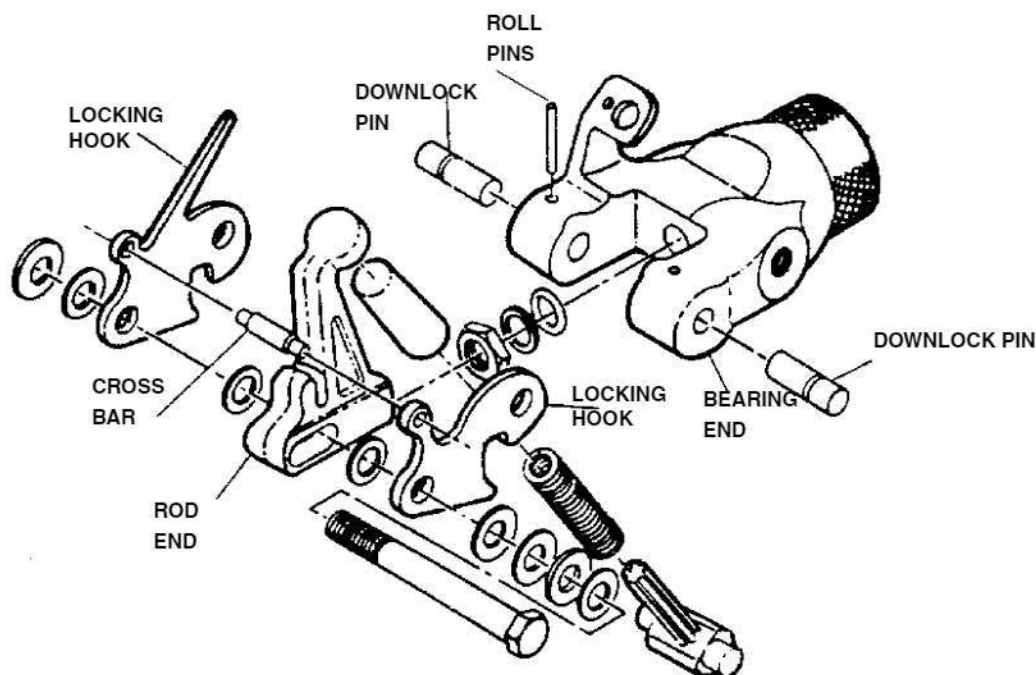
There have been problems with the nose gear actuator bearing end pins that the downlock hooks engage. Service Bulletin SEB95-20 for the single engine aircraft and MEB95-14 for the 303 and 337 series aircraft advises owners to have the pins inspected for looseness. The pins are a press fit in the actuator bearing end and retained with a roll pin. The bearing end pins break at the retaining groove that the roll pin engages. This allows the pin to back out and prevents the downlock hooks from

movement in any direction. Check the other pin in the same manner. If any looseness is detected, the actuator bearing will have to be inspected to see if the hole size for the pin is still within limits. The maximum size for the downlock pin bore is 0.3760 inches. If the holes are out of tolerance, the bearing end will have to be replaced. If the bearing end is serviceable, the kit described in SEB95-20, SK210-155 for the single engine aircraft or MEB95-14 for the 303, SK303-47 and 337, SK337-70 aircraft can be installed. The new pins contained in the kit are retained by a roll pin that passes through the center of the pin so new holes must be drilled in the actuator bearing end. A drill guide is provided in the kit.

The condition of the downlock pins is impossible to inspect on a preflight walk around inspection. The hooks hide the inboard portions of the pins, and this is the area of concern. The recommendation CPA makes is to have the inspection called for in SEB95-20 or MEB95-14 done whenever the airplane is jacked, and be sure it is entered in the aircraft's maintenance records. This gives a known good starting point and may give you some leverage if a failure occurs after a tug or tractor has towed the aircraft. The nose gear down switch is made by contact with the right hook so anytime the gear system fails to indicate a green light gear down position, be sure to have the actuator pins inspected and noted in the logbook no matter what the actual problem turns out to be.
